Manhole Inspection Summary

Manhole # S23M__029MH

Location Address: **1531 Ramsay st (behind house)**

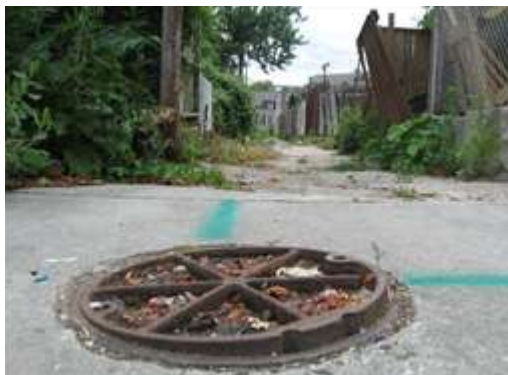
Misc

extra Location View, cover upside-down

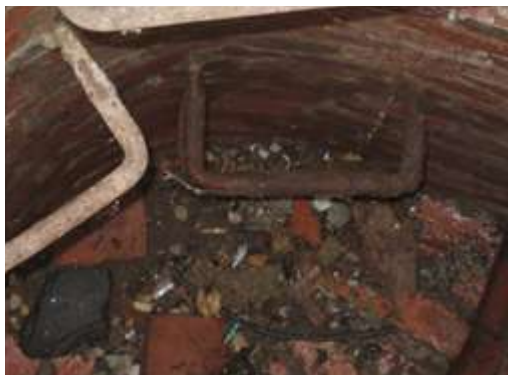
Defect 3

Count: **4** Missing: **0** ☒ **Corroded**

steps corroded

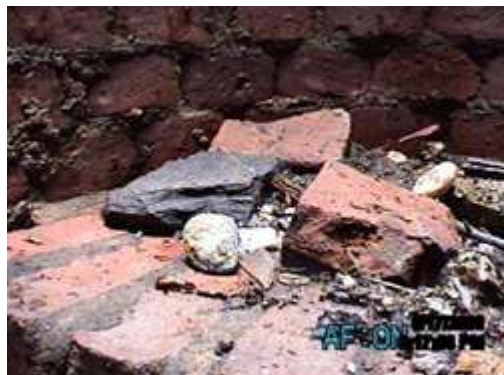
Defect 1

Condition: ☐ Sound ☐ Cracked ☐ Root Intrusion ☐ Deteriorated ☐ Leaks ☒ **Debris**

bench debris

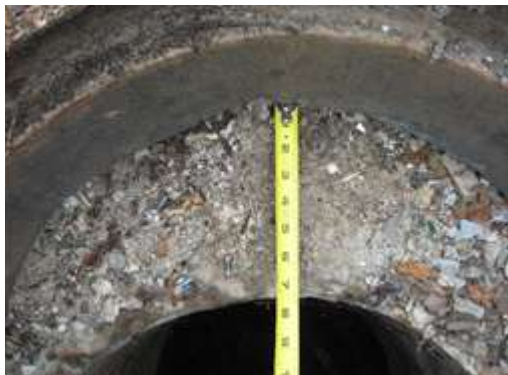
Defect 2

Offset: **7** (in.)

frame offset 7 inches

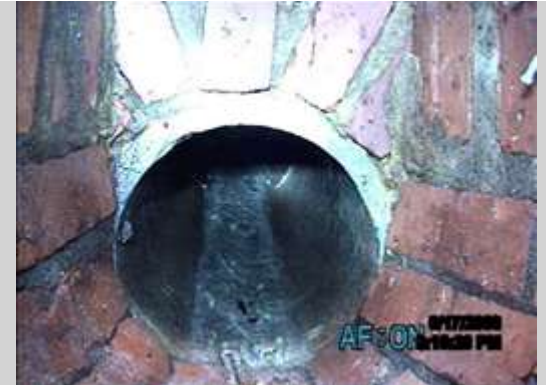
12 O'Clock Outflow

8 in. Circular Gravity Sewer
Pipe Out @ 12 O'Clock

Invert Depth: **8.72** (ft.) Flow Characteristics: **Slow**

Infiltration: **None** Pipe Seal Cond: **Sound**

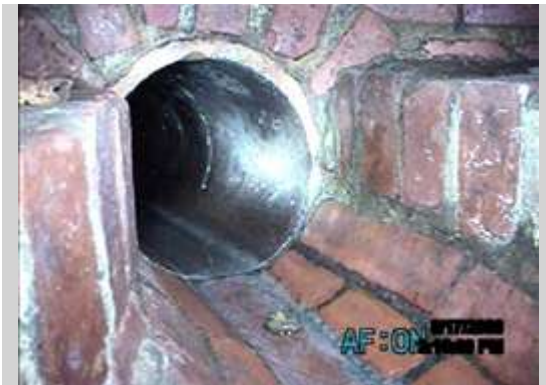
3 O'Clock Inflow

8 in. Circular Gravity Sewer
Pipe In @ 3 O'Clock

Invert Depth: **7.09** (ft.) Flow Characteristics: **Slow**

Infiltration: **None** Pipe Seal Cond: **Sound**

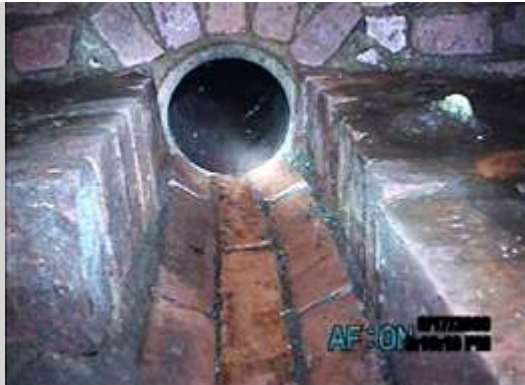
6 O'Clock Inflow

6 in. Circular Gravity Sewer

Pipe In @ 6 O'Clock

Invert Depth: **7.73** (ft.) Flow Characteristics: **None**

Connects To: **House connection / Service line**

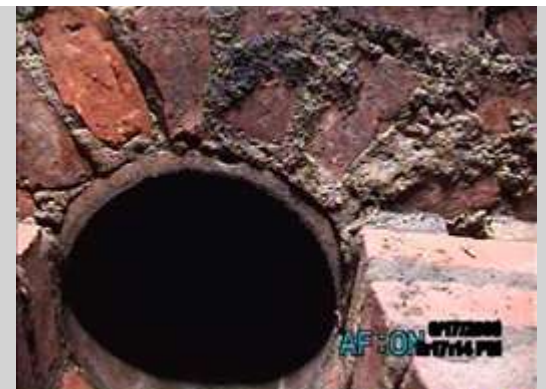
9 O'Clock Inflow

8 in. Circular Gravity Sewer

Pipe In @ 9 O'Clock

Invert Depth: **8.15** (ft.) Flow Characteristics: **Slow**

Infiltration: **None**
